CHAPTER 2

NEW TEST SECTIONS

Five new test sections were constructed during the previous 2 years. The new test sections are:

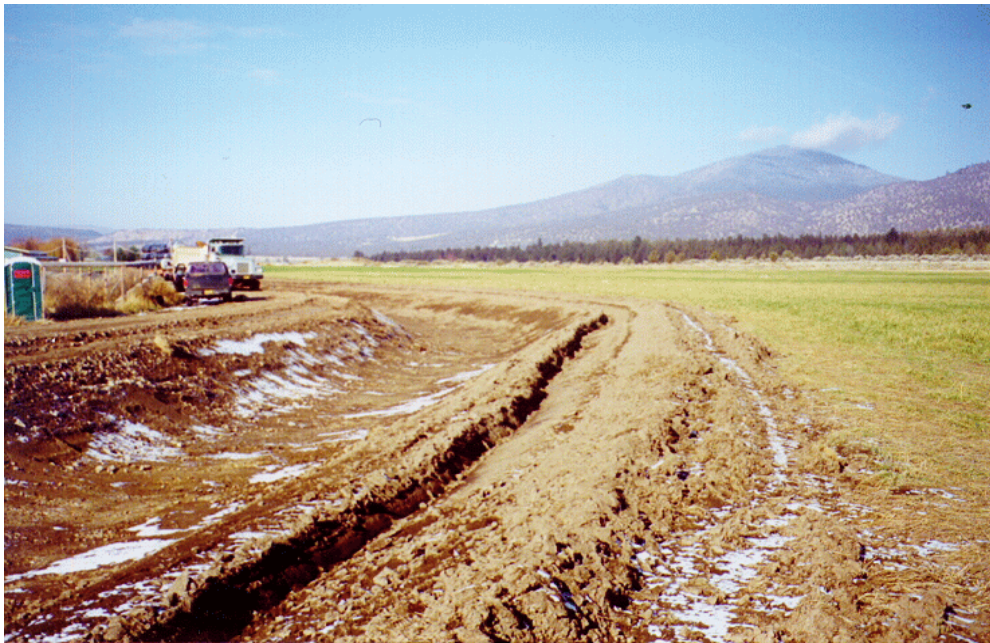
Photograph 2.—The irrigation district reshaped the canal prism, restored the 1½:1 side slopes, and cut a 6-inch deep V-notch anchor trench on each bank.

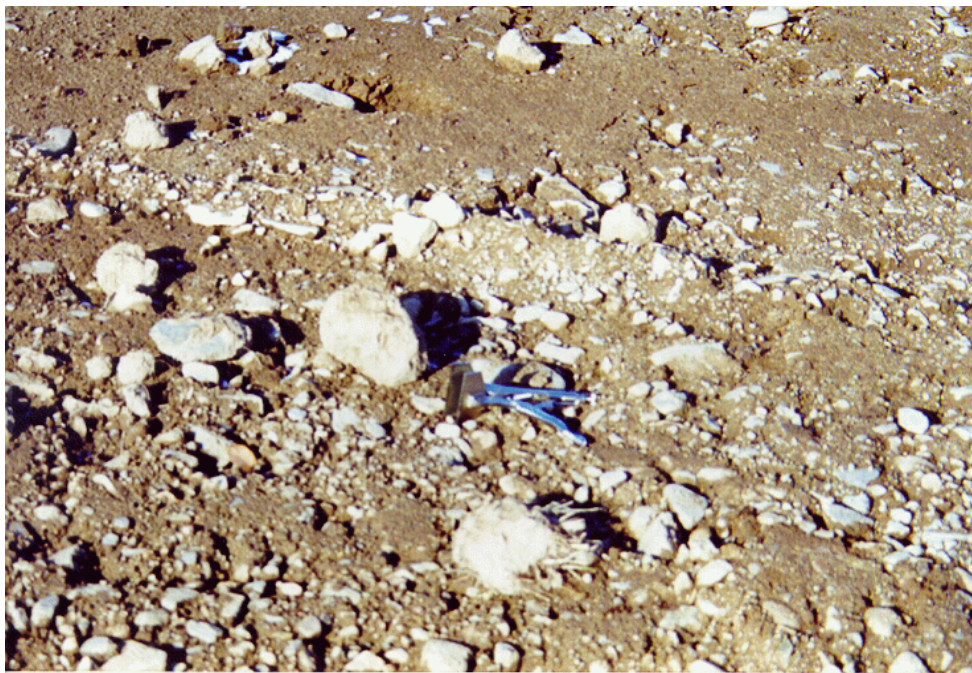
Photograph 3.—The subgrade was quite rough, and offsets were up to 6 inches.

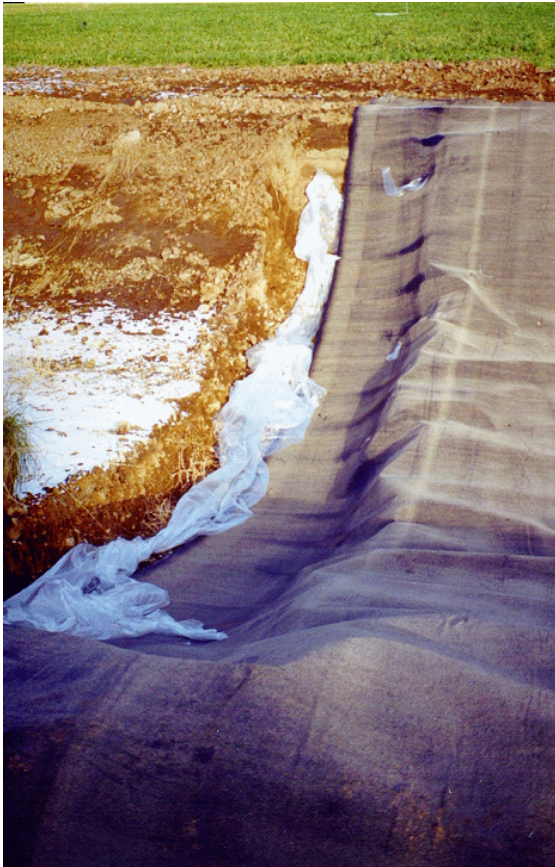
Photograph 4.—Geomembrane is placed in the cut-off trench at the downstream end of the test section.

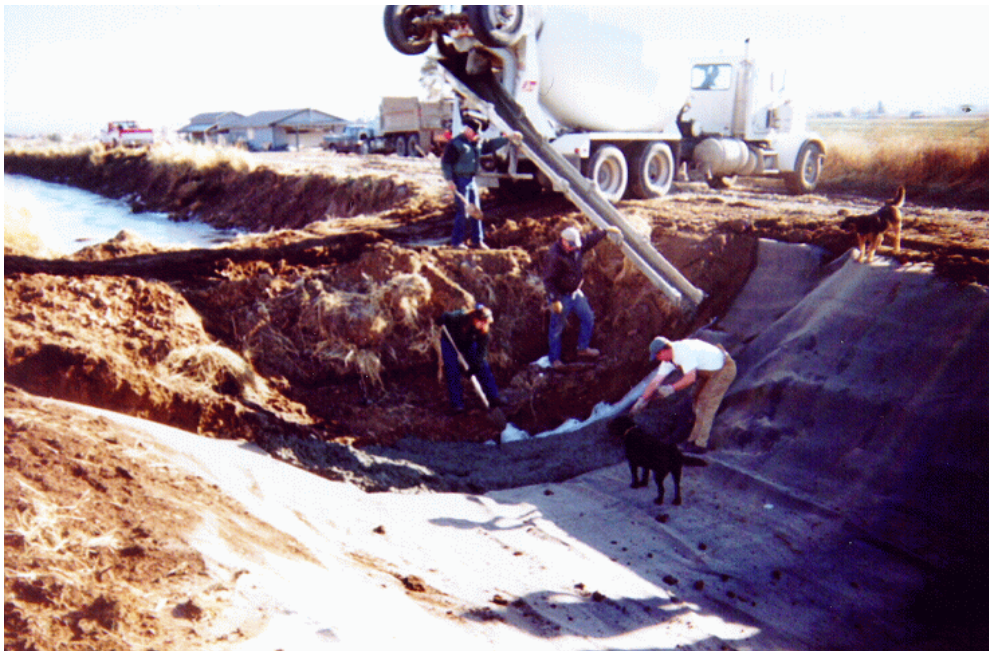
Photograph 5.—Concrete placed over geomembrane in the upstream cut-off trench.

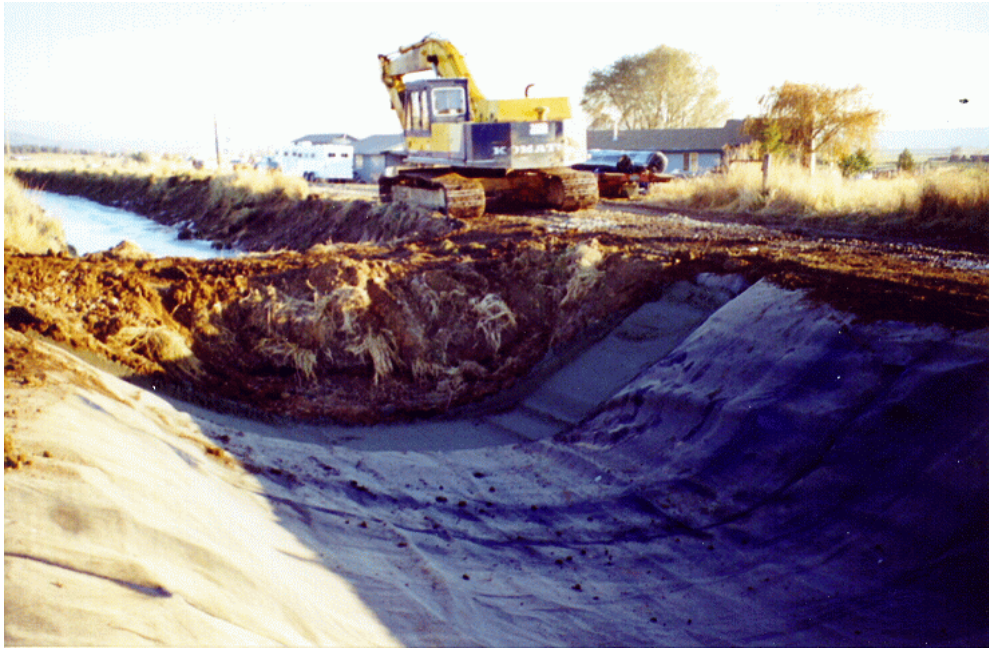
Photograph 6.—Completed upstream cut-off trench.

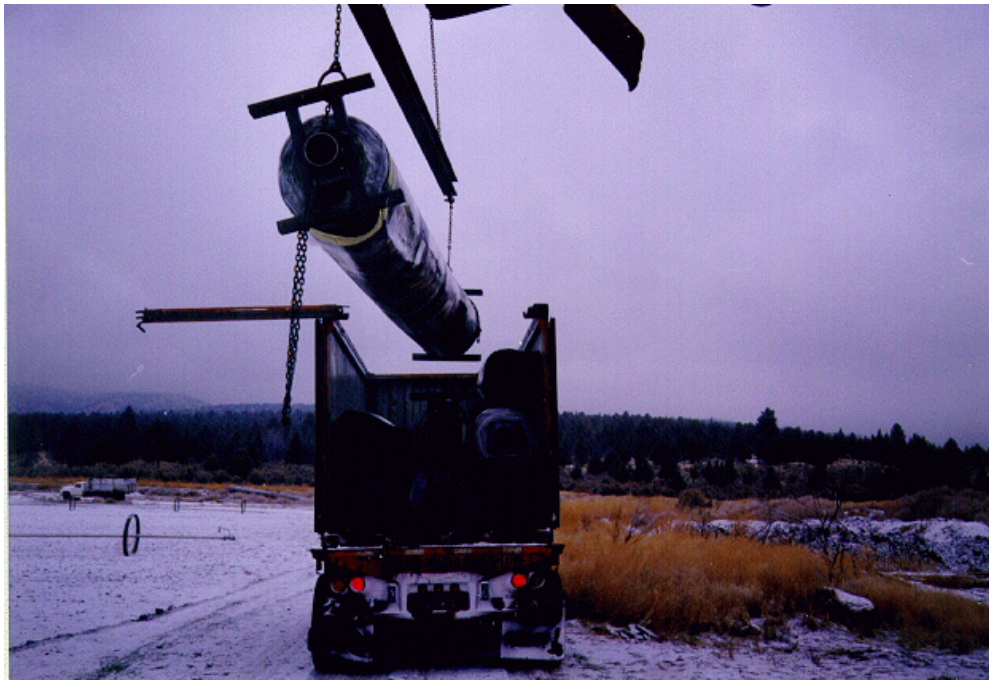
Photograph 7.—Trackhoe unloads rolls of Colas geomembrane from shipping container.

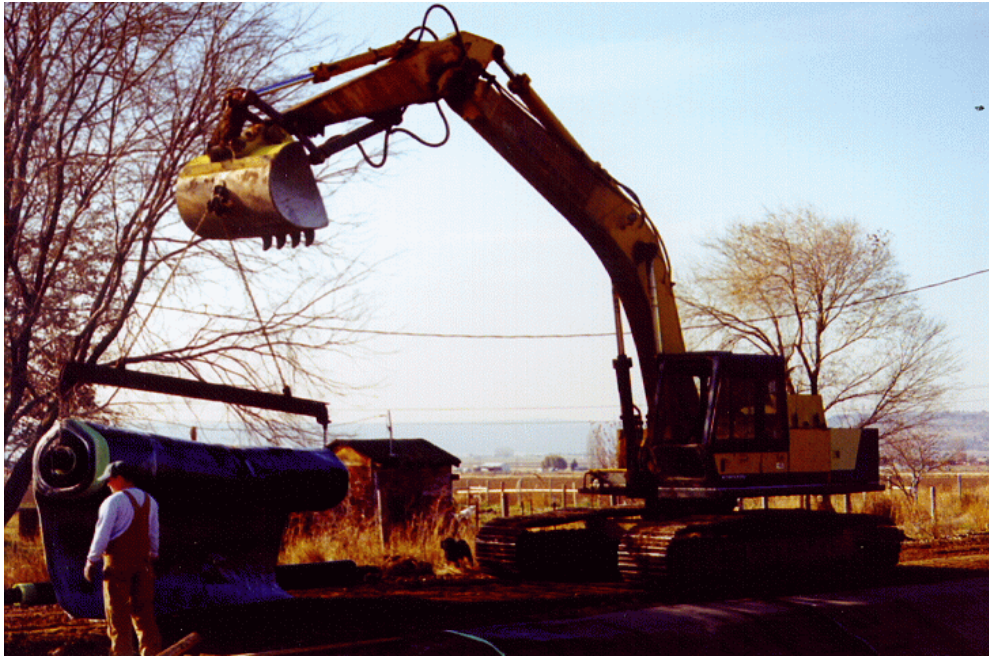
Photograph 8.—Trackhoe equipped with lifting bar (fabricated by the irrigation district) handles the rolls of geomembrane.

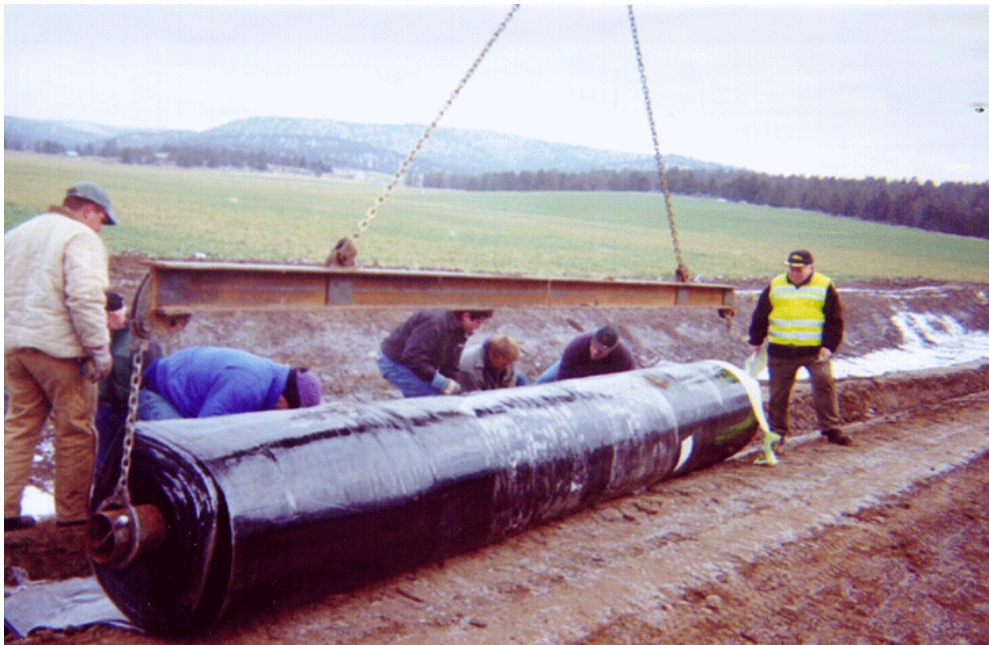
Photograph 9.—Close-up of lifting bar.

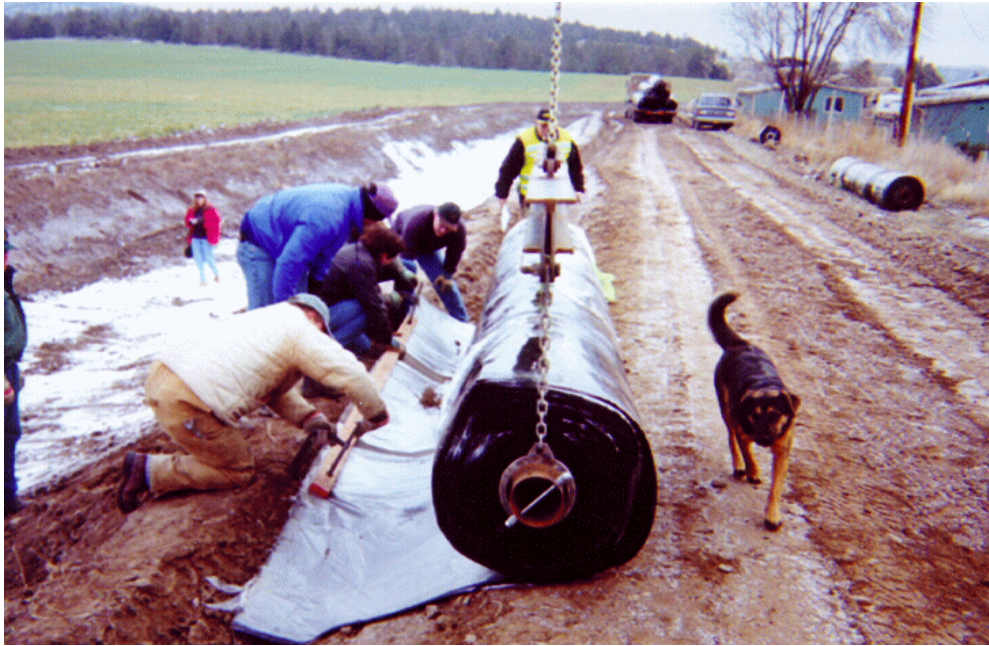
Photograph 10.—District used 2 by 4s and clamps to grip the geomembrane.

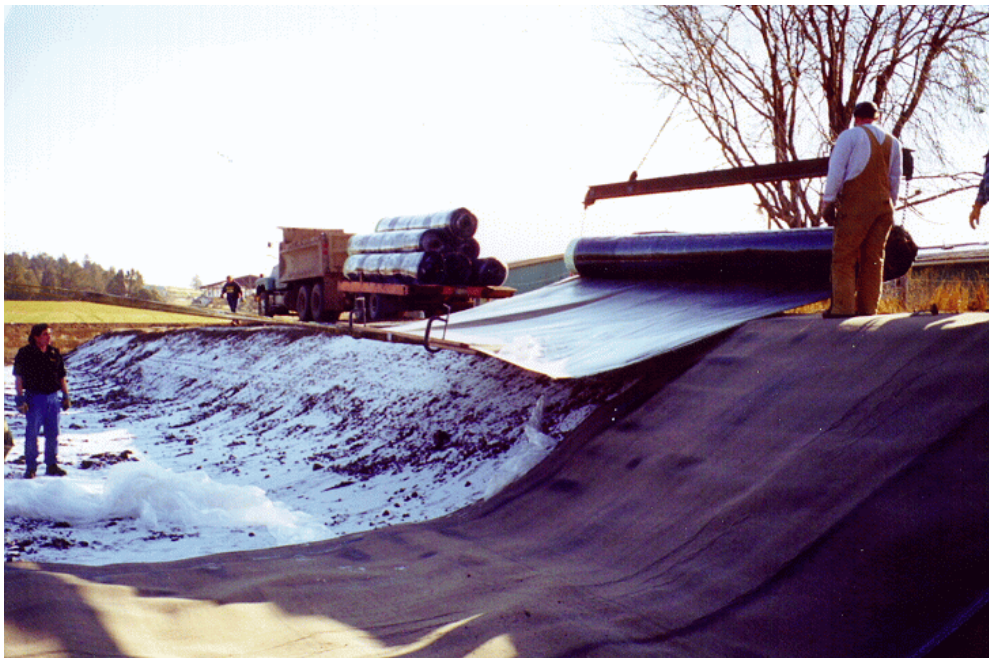
Photograph 11.—Geomembrane is pulled off the roll and into the canal.

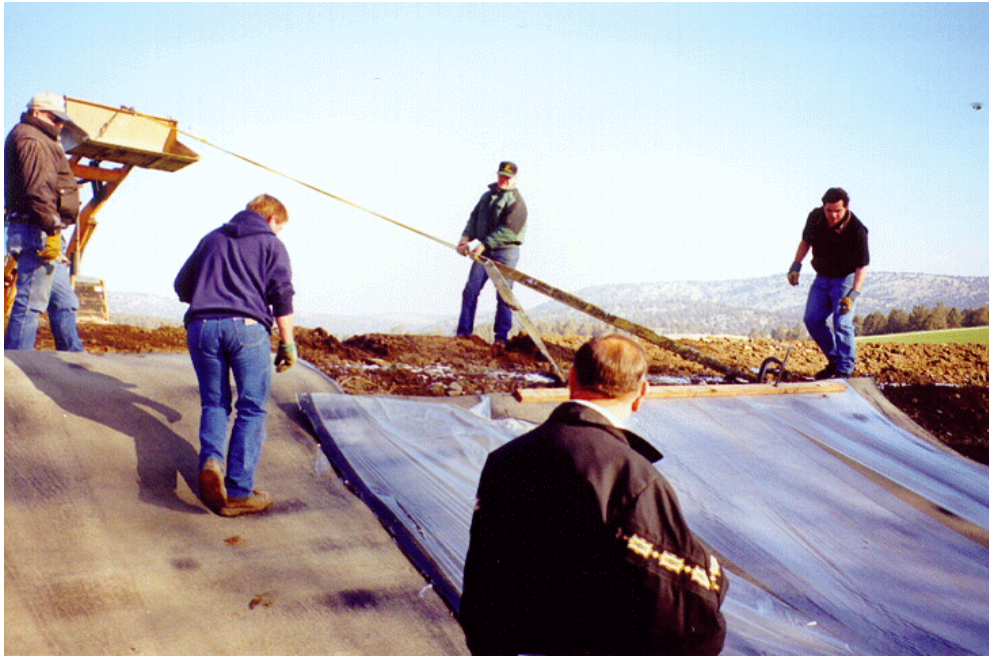
Photograph 12.—Small frontloader pulls the geomembrane up the far bank and into position.

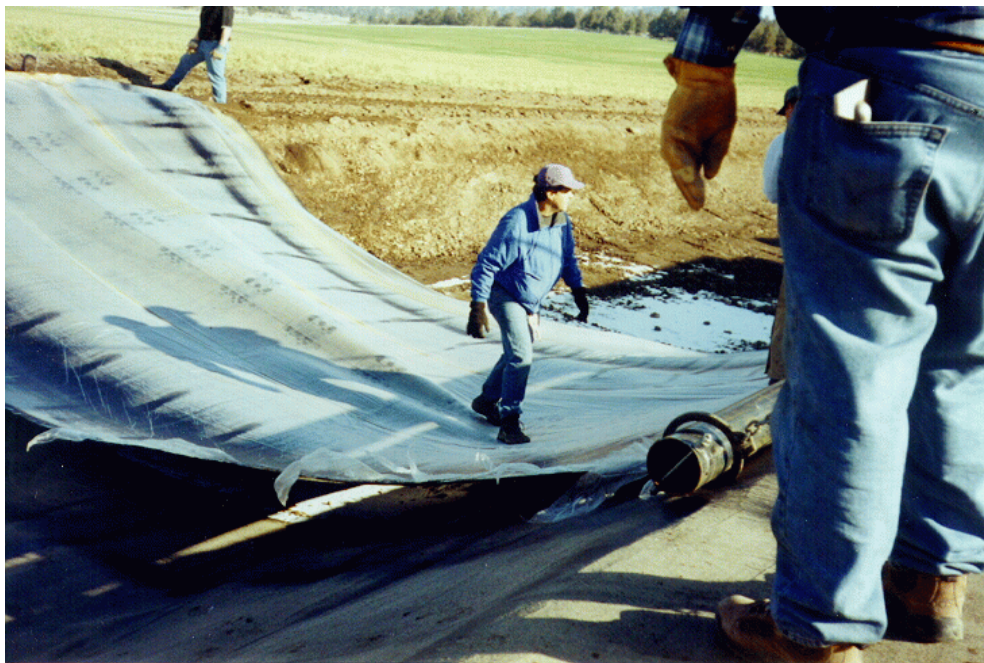
Photograph 13.—Geomembrane easily supports worker while suspended across the canal.

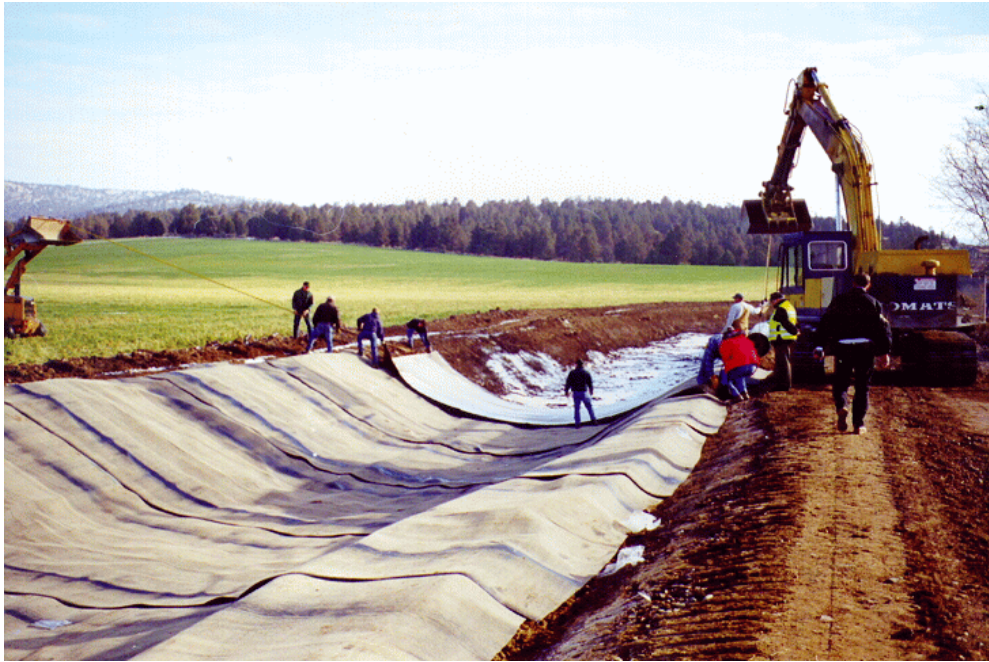
Photograph 14.—Trackhoe and front loader coordinate precise placement of the geomembrane liner.

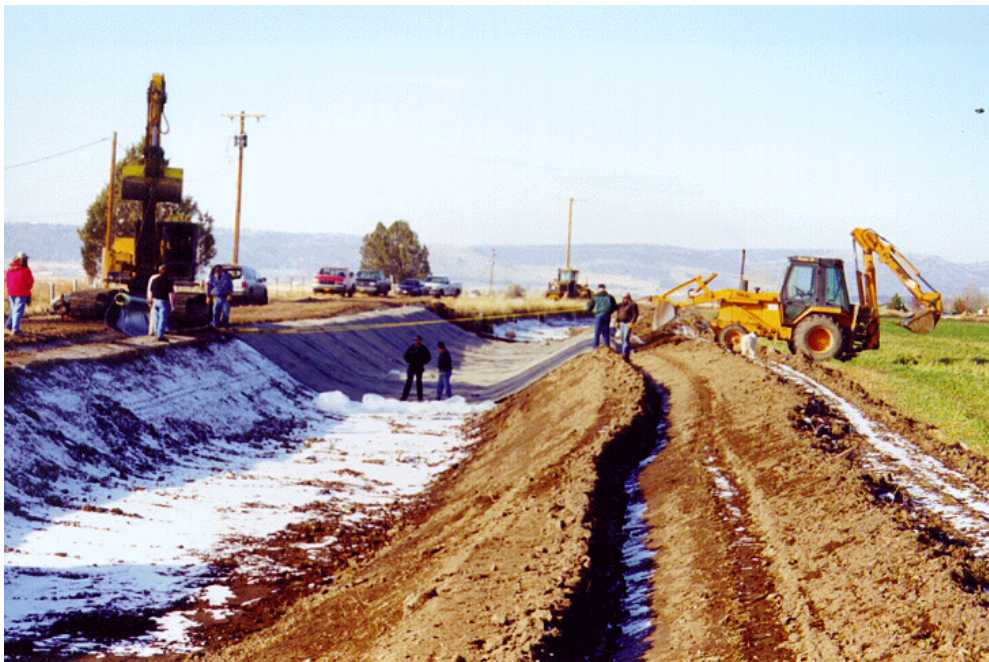
Photograph 15.—Overview of liner placement.

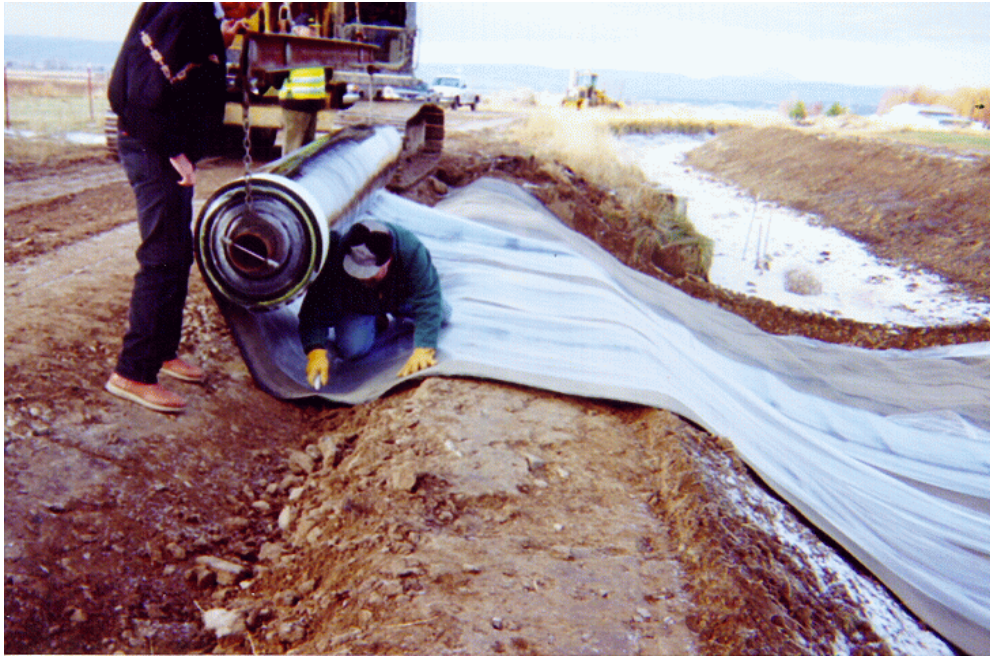
Photograph 16.—After positioning, the liner is cut to length with little or no waste.

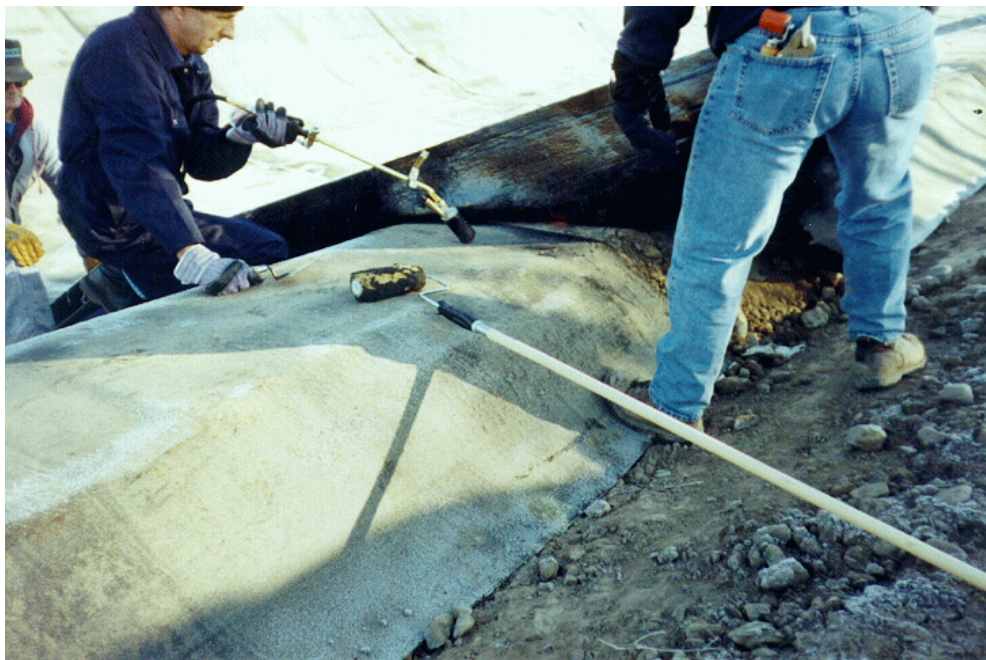
Photograph 17.—A propane torch is used to seam the geomembrane.

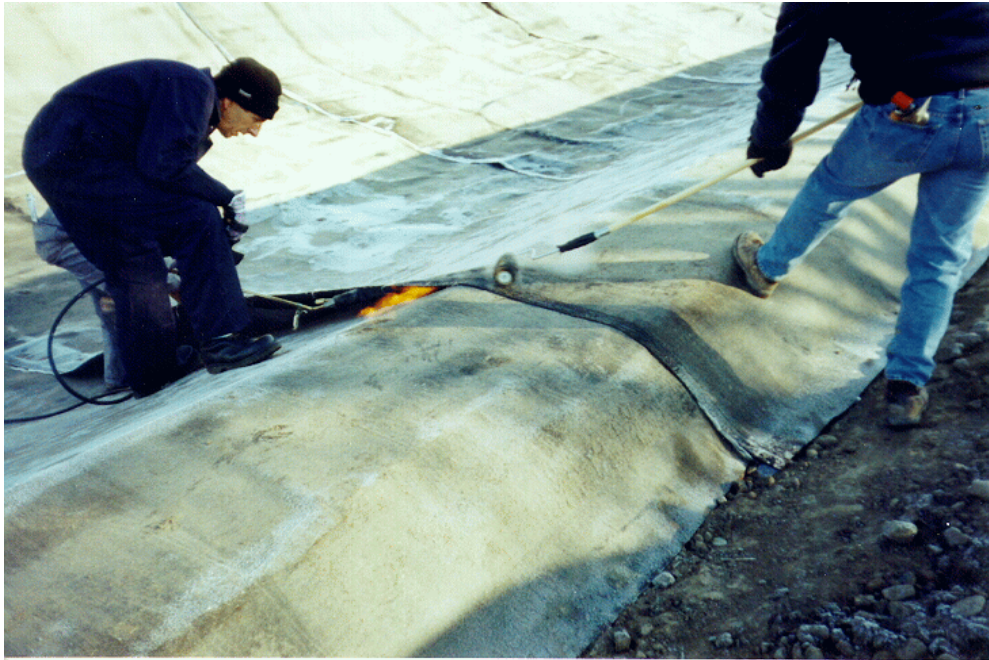
Photograph 18.—After heating with the torch, seams are pressed together with a paint roller.

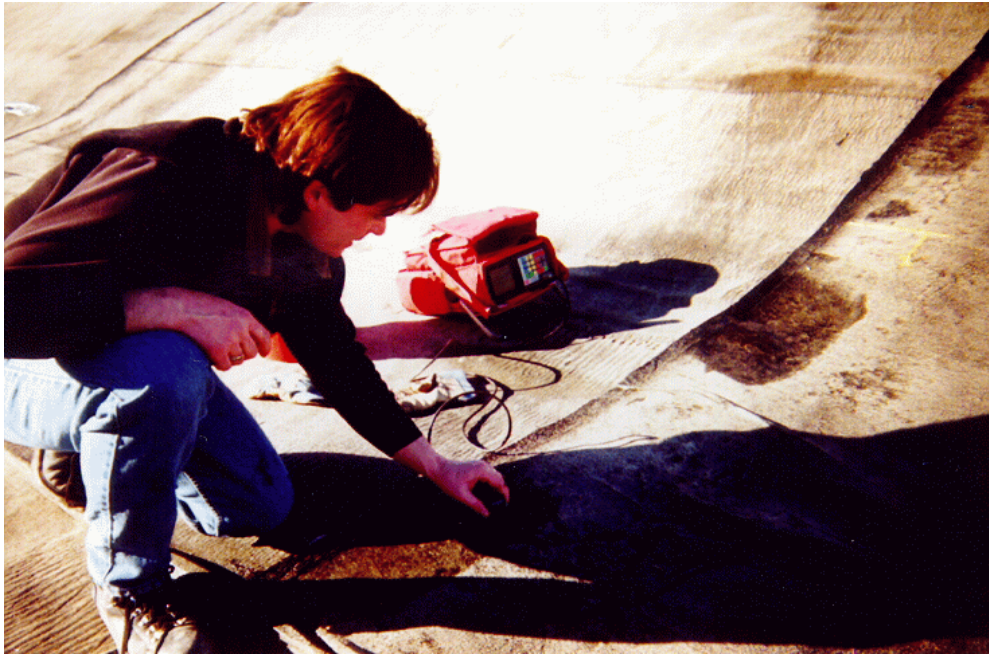
Photograph 20.—Ultrasonic testing of the seam.

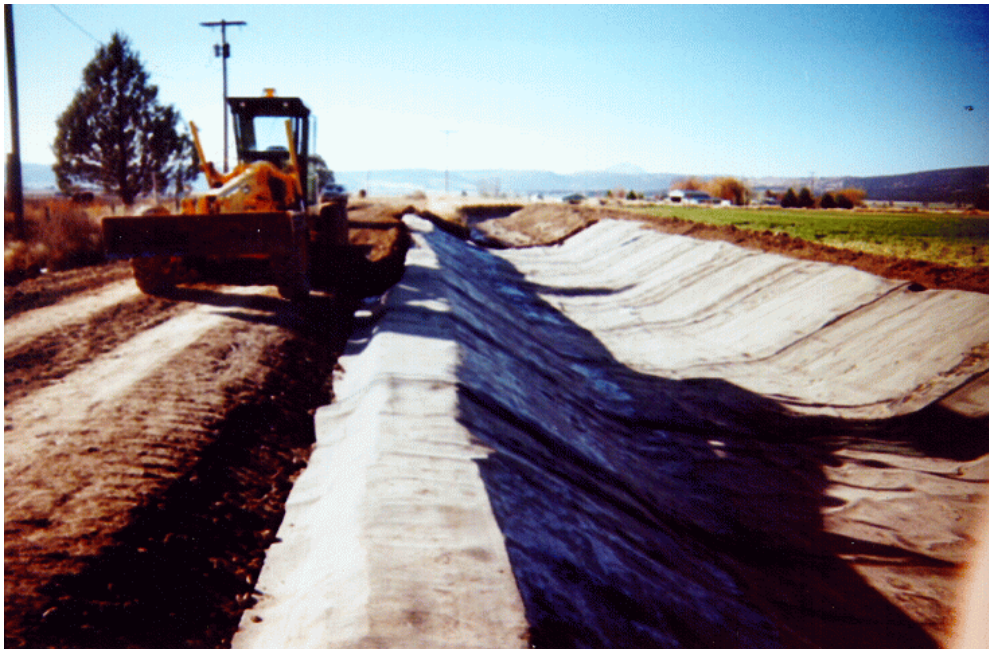
Photograph 21.—The grader backfills the V-notch anchor trench.

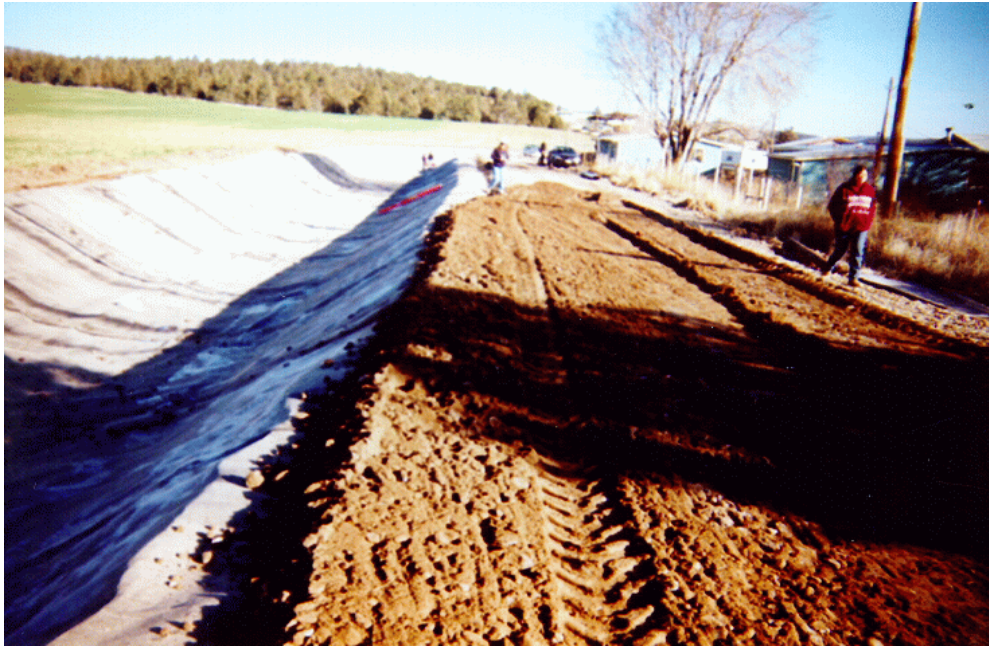
Photograph 22.—The anchor trench has been backfilled up to the edge of the canal.

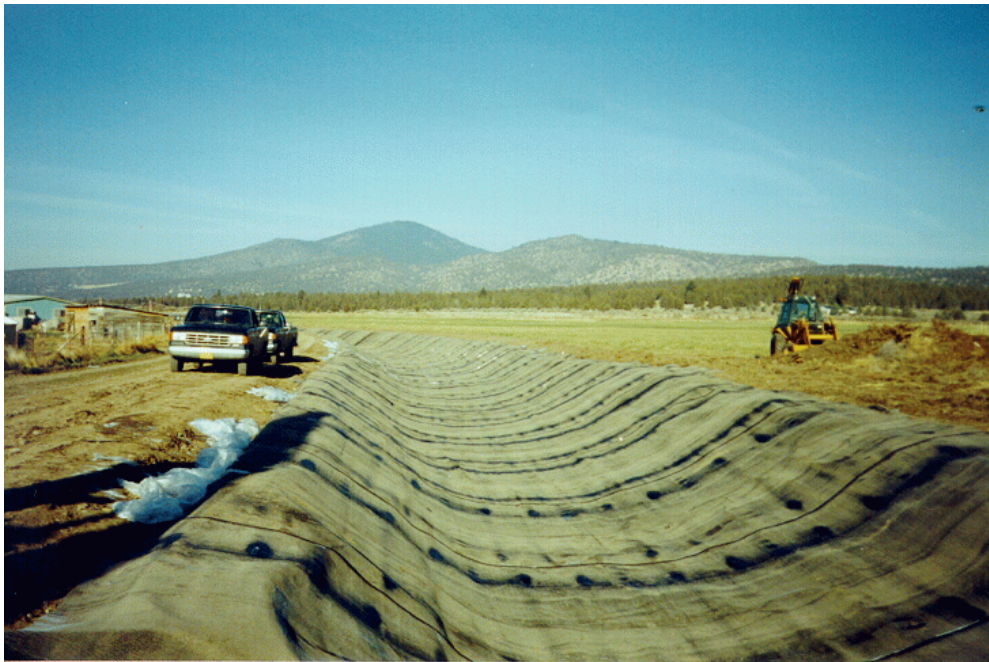
Photograph 23.—Finished Colas test section.

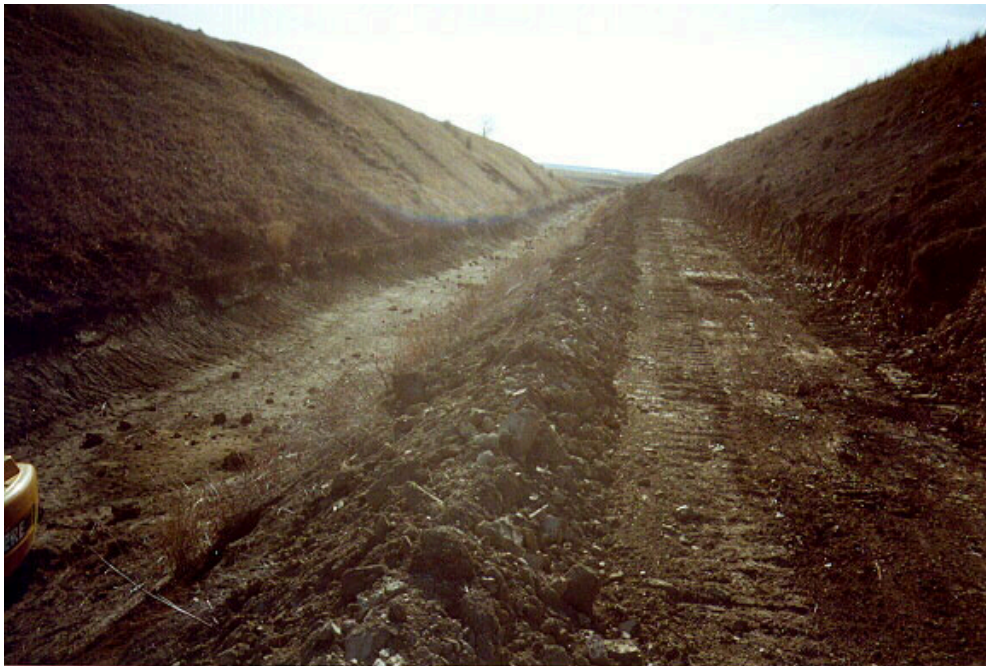
Photograph 2.—Canal subgrade through the "Deep Cut." Large dirt clods in the invert rolled down the embankment during road improvement.

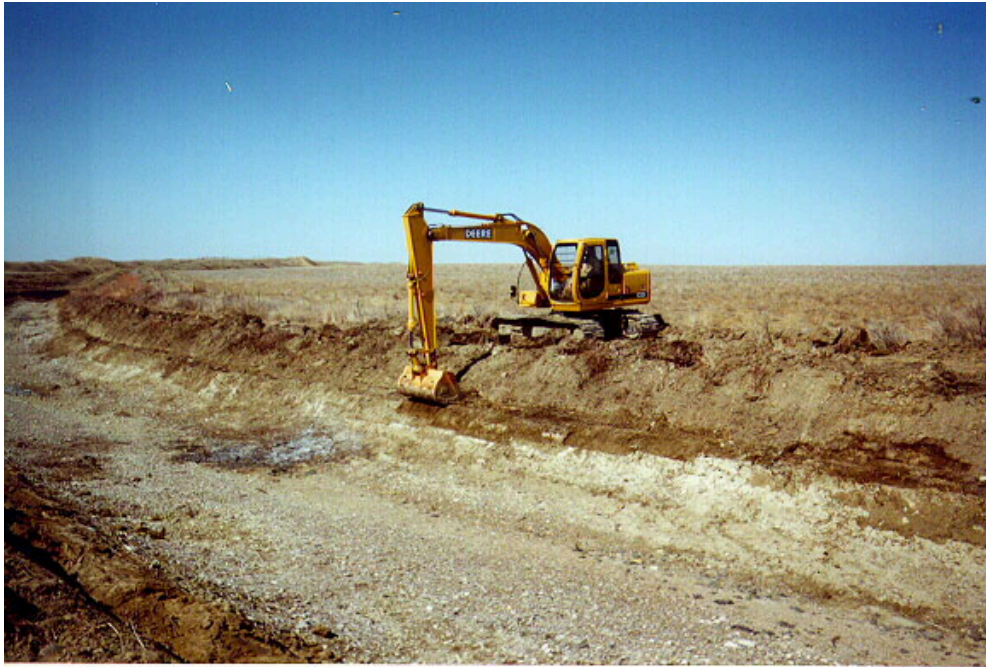
Photograph 3.—Backhoe excavates the 2-foot-wide anchor berm located 1 foot above the water line.

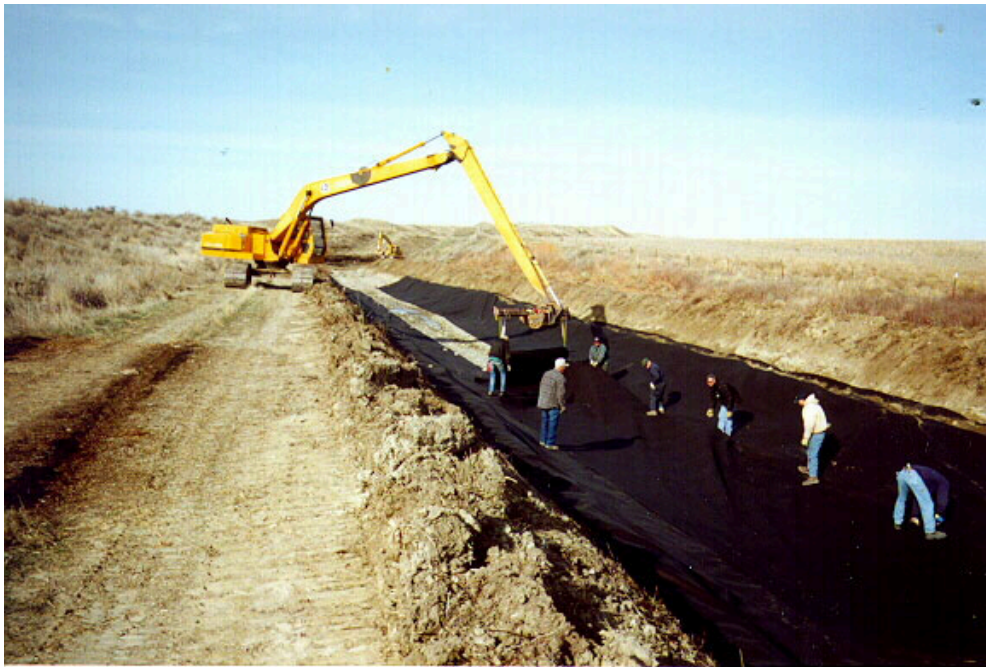
The subgrade of the downstream 1,300 feet of the test section contains large numbers of rounded river rocks in the subgrade of up to 6 inches in diameter. The subgrade became less rocky in the upstream direction. Therefore, the lower 1,300 feet of the test section was covered with a 10-oz geotextile cushion. The cost estimates include both options.

Photograph 4.—Geotextile cushion was placed over rocky subgrade in the downstream 1,300 feet of the test section. The 10-oz geotextile is placed lengthwise down the canal.

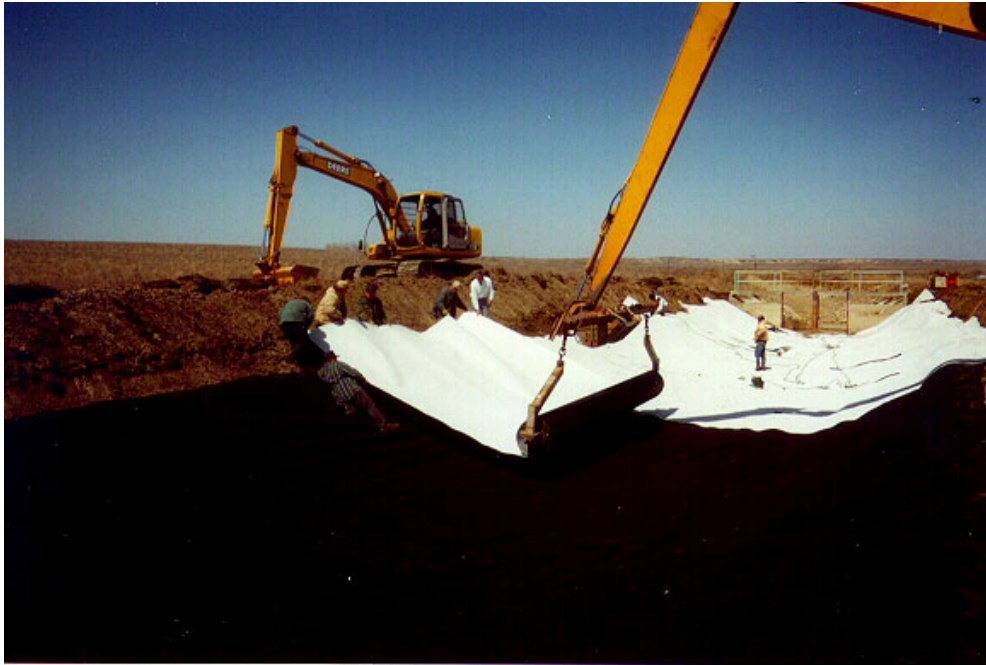
Photograph 5.—Starting at the downstream check structure, the geomembrane is installed perpendicular to the flow in the canal and overlapped downstream.

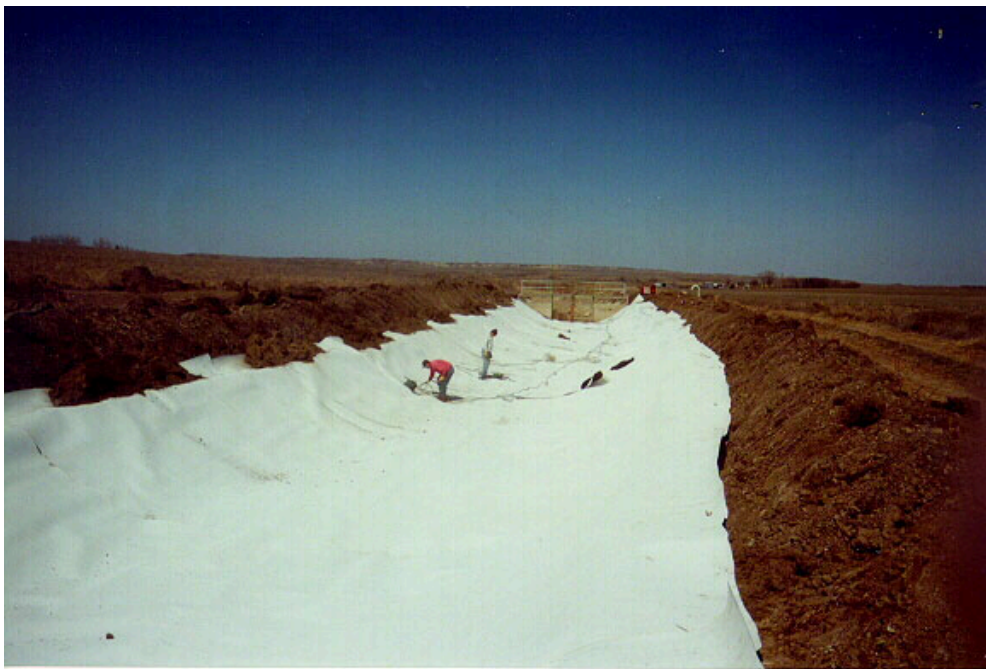
Photograph 6.—View of nearly complete installation in the downstream section.

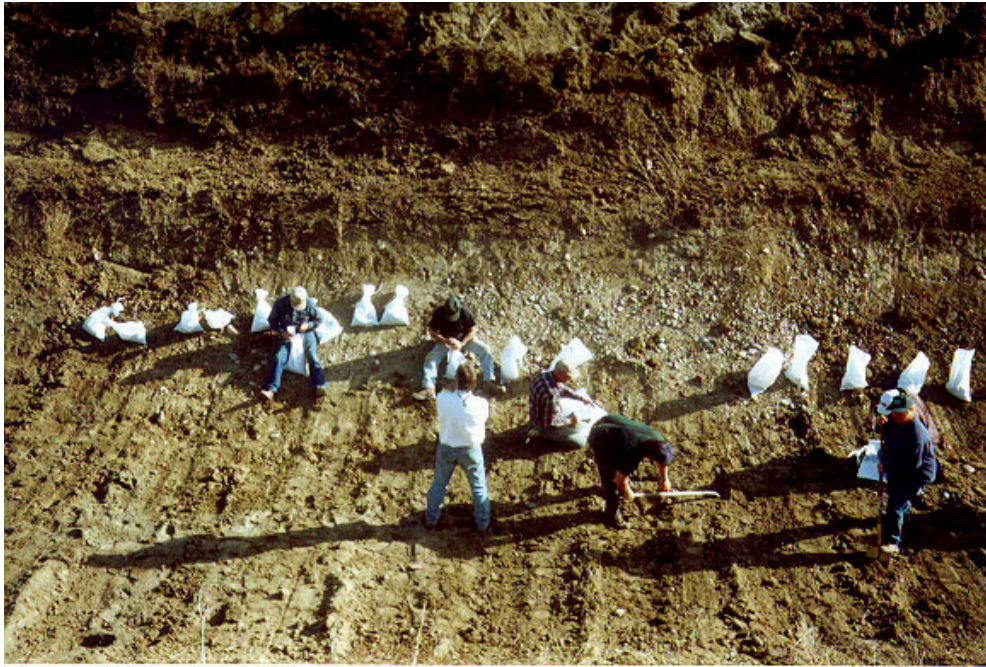
Photograph 7.—When the wind came up, sandbags were needed to temporarily secure the geomembrane. Laborers shown filling the sandbags.

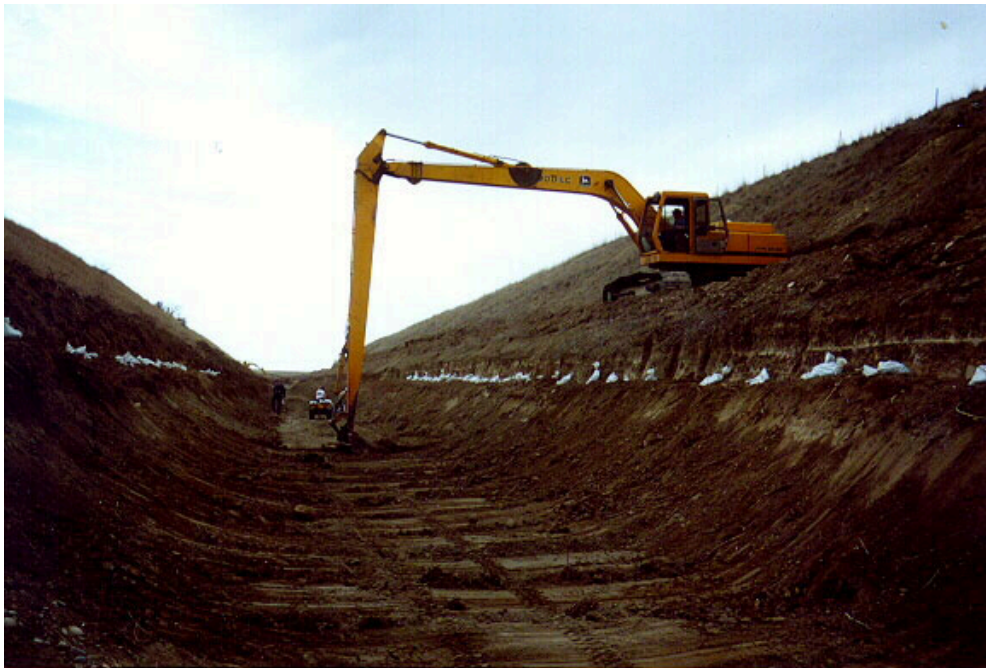
Photograph 8.—Large Trackhoe performs final trimming on the subgrade. Note the sandbags in position on the anchor bench.

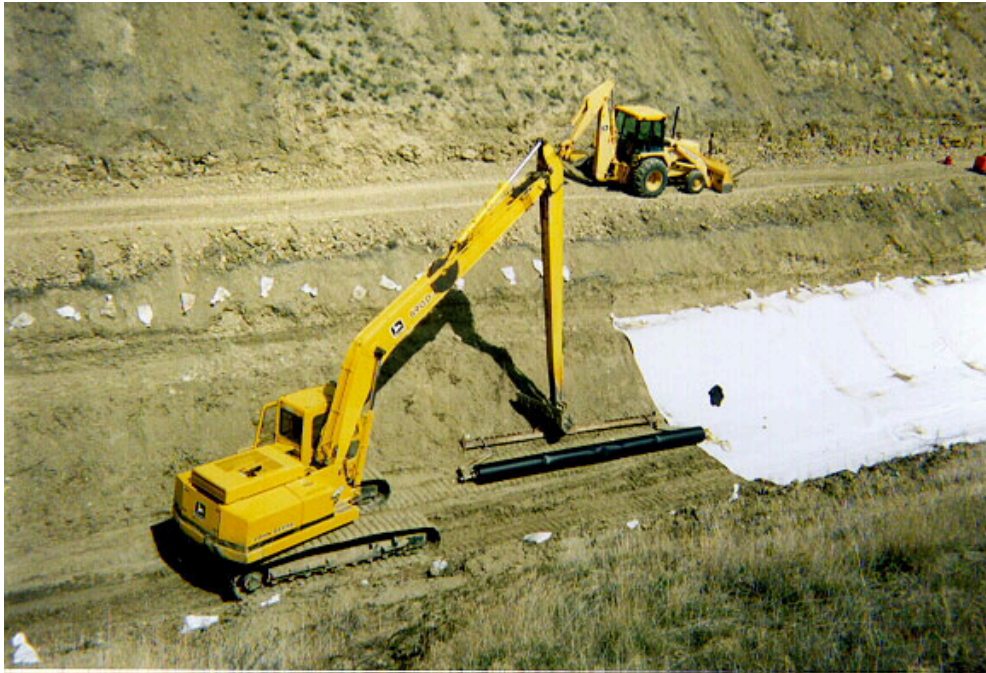
Photograph 9.—Trackhoe operating in the canal invert to unroll geomembrane across the canal.

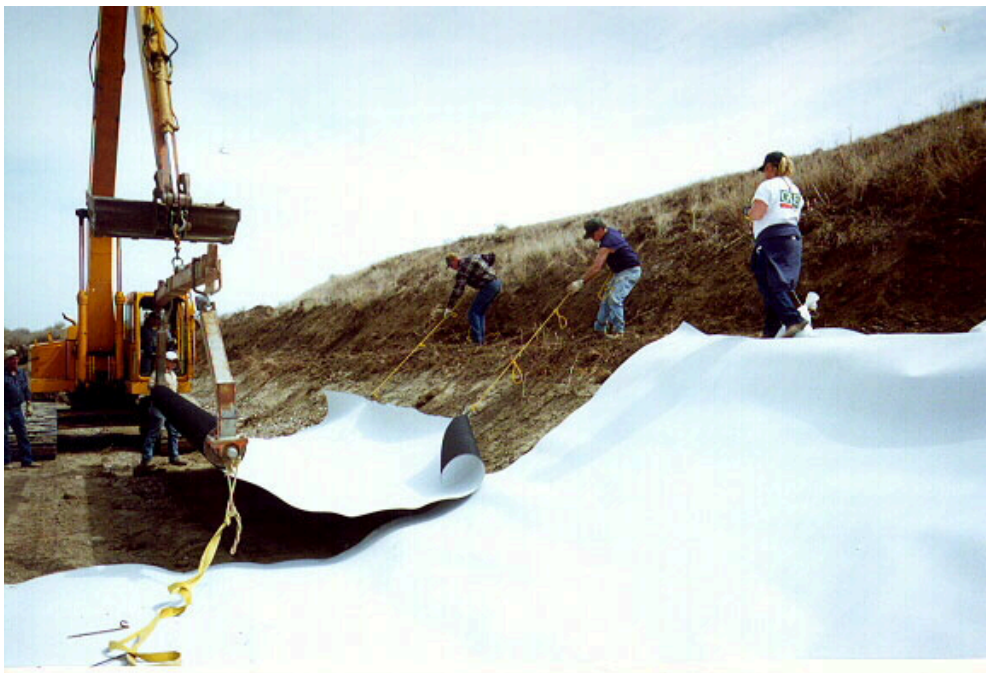
Photograph 10.—Crew assists in unrolling and placing of the geomembrane.

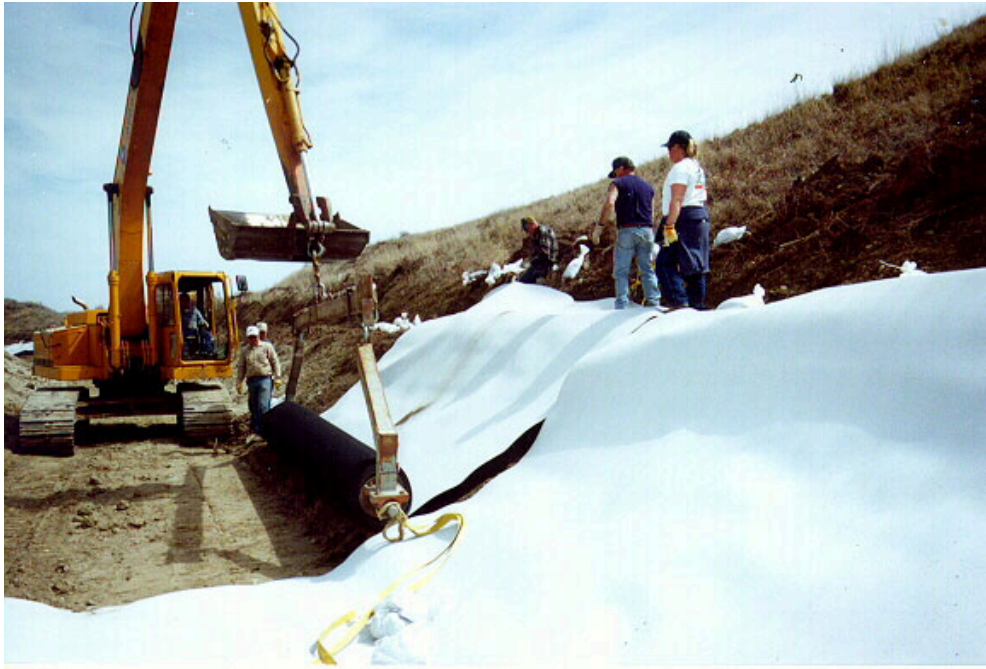
Photograph 11.—Trackhoe unrolls geomembrane while sandbags and 1-foot tell pins hold it in place on the anchor bench.

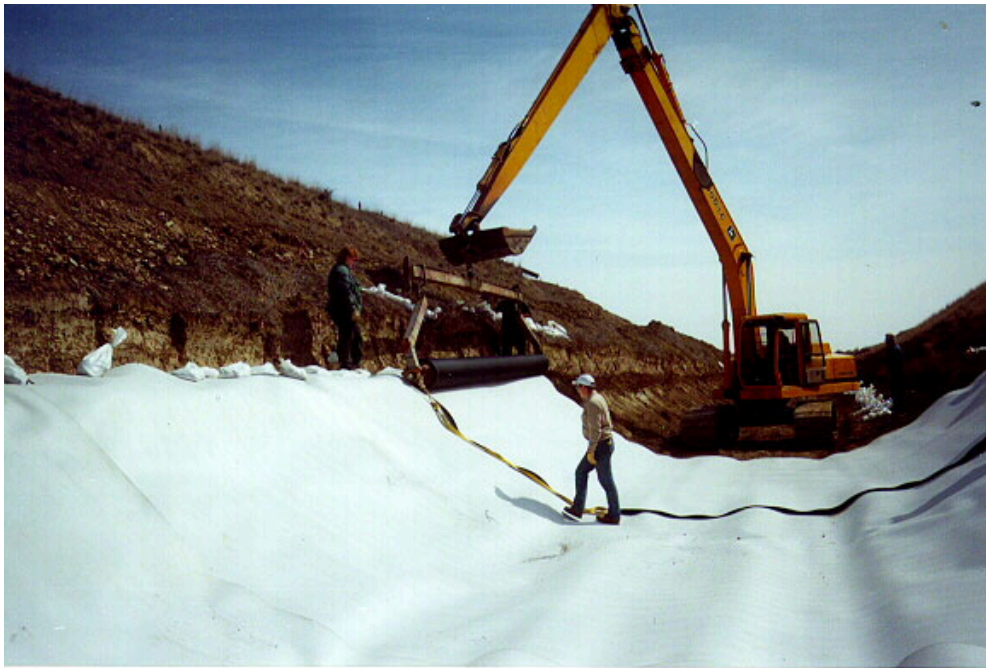
Photograph 12.—Trackhoe unrolls geomembrane up the other bank, where it will be cut to size and secured to the anchor bench.

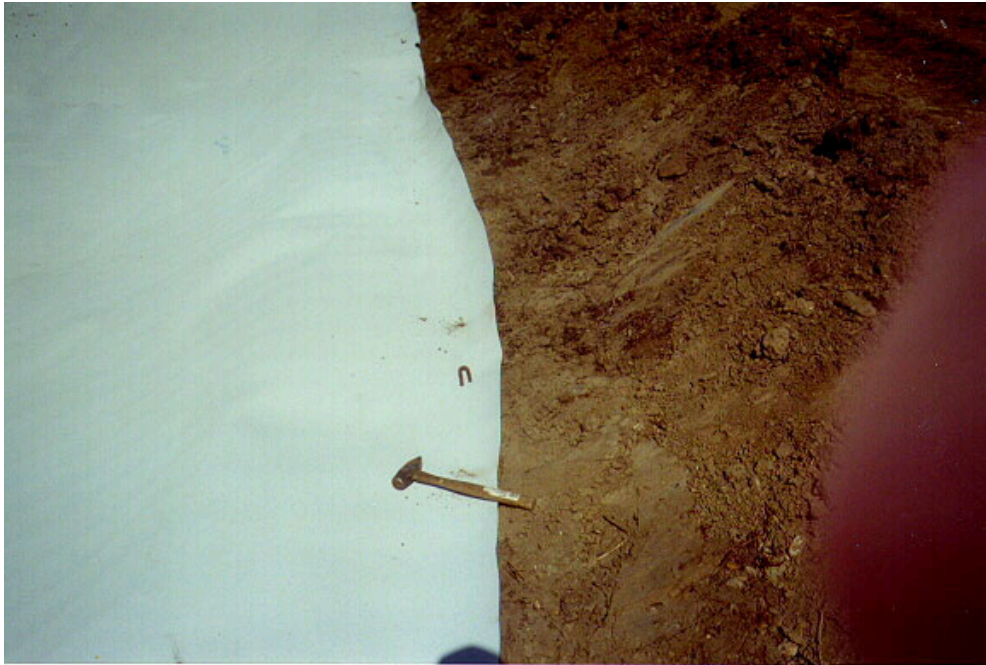
Photograph 13.—Steel pin has been driven into the anchor bench to secure the Geomembrane.

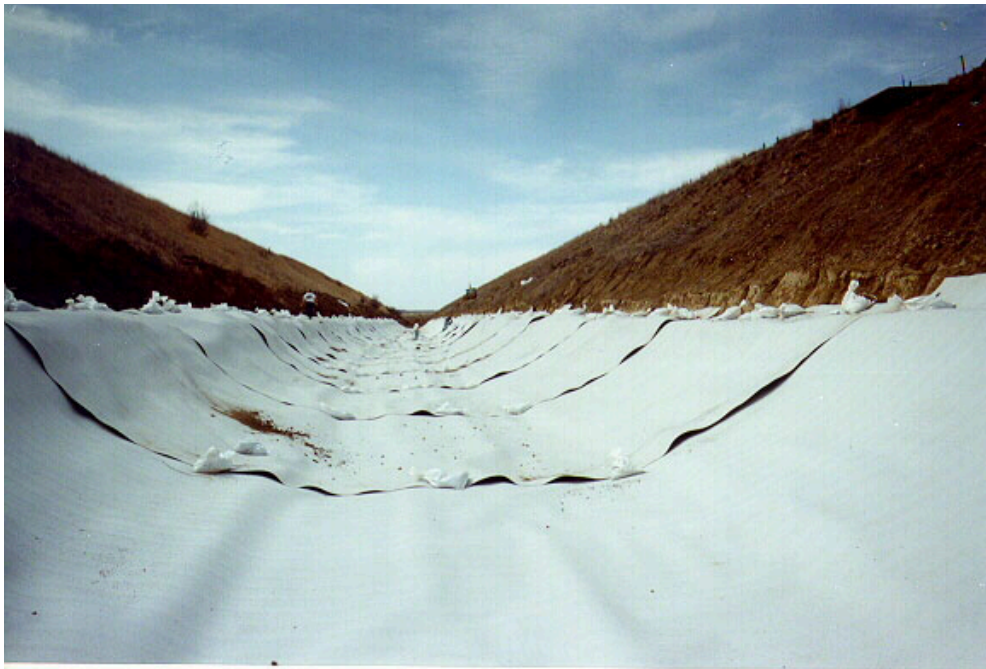
Photograph 14.—Several panels have been installed across the canal and temporarily secured with sandbags. Geomembrane panels still need to be seamed, and the anchor bench needs to be backfilled.
